INDOOR AIR QUALITY ASSESSMENT

**Department of Revenue
333 East Street
Pittsfield, MA**

Prepared by:
Massachusetts Department of Public Health
Bureau of Environmental Health
Indoor Air Quality Program
October 2016

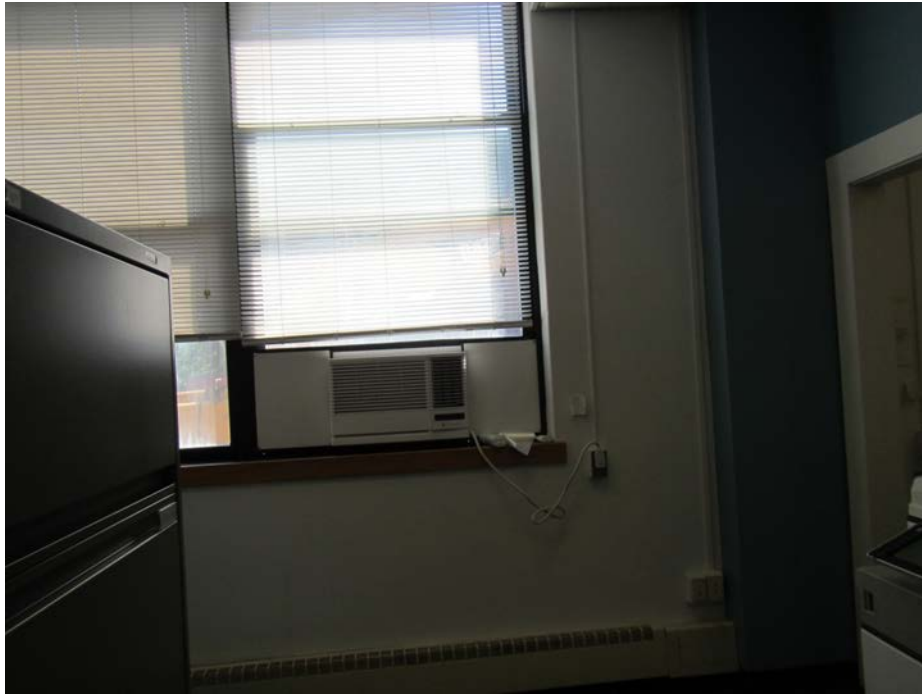
Picture 1

The DOR office suite does not have a built-in source of mechanical ventilation. Heating is provided by baseboard radiators. Cooling is provided by window-mounted air conditioners (WAC) installed in many of the suite's windows (Picture 1). During the non-cooling season, these units are reportedly used to provide some fresh air in the "fan only" mode. Opening some windows during the non-cooling season can also assist with air exchange. At the time of the visit, renovation work on the building envelope, including brick repointing, was occurring. Windows should be kept closed when this work is impacting the side of the building where this office suite is located to prevent exposure to construction-related pollutants and noise.

Window air conditioner

2. Use openable windows and WACs in cooling or fan-only mode to provide fresh air. Avoid opening the windows while envelope renovations are occurring on the near side of the building.

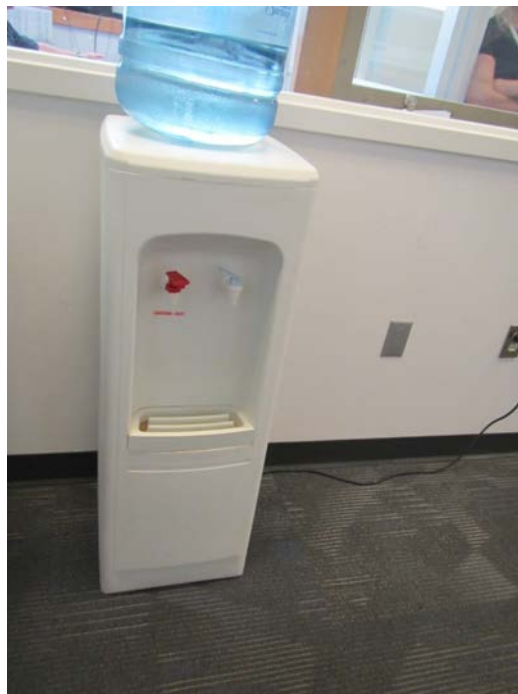
Picture 2

Water dispensers were observed in carpeted areas (Picture 2). These appliances may spill or leak and lead to carpet damage and microbial growth. It is recommended that these appliances be located in areas without carpeting or on waterproof mats. The kitchen sink cabinet had water stains, which suggests that leaks or condensation is occurring. The area underneath sinks tends to be a moist environment, so storage of porous items or large amounts of items should be avoided. These areas should be checked periodically for leaks and dampness.

Water dispenser on carpet

3. Consider locating water dispensers in non-carpeted areas or place on a waterproof mat.
4. Maintain plants, place on waterproof drip pans and avoid overwatering.

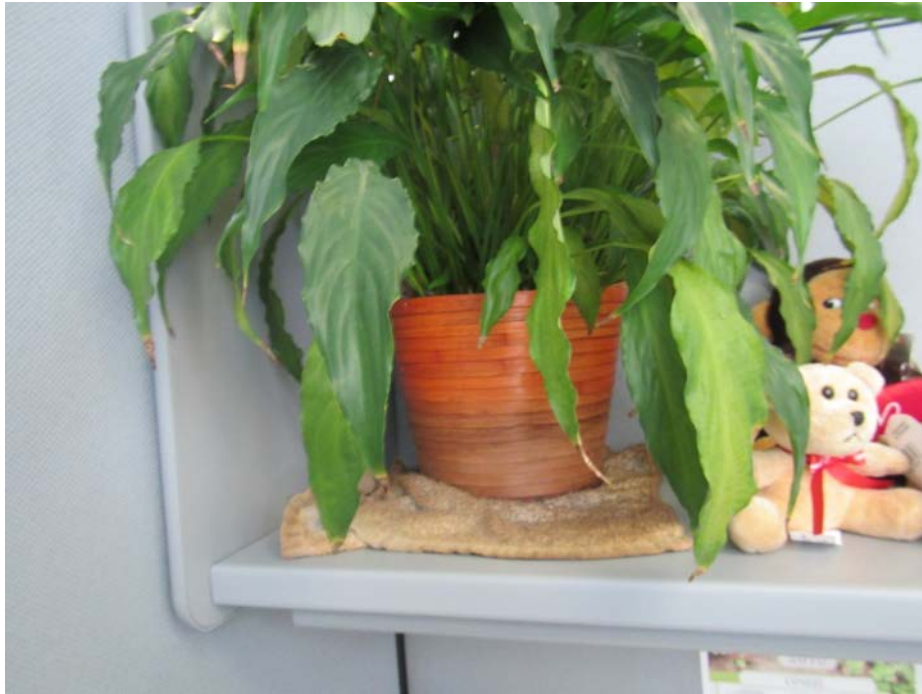
Picture 3

A plant was observed on a towel, which is a porous material (Picture 3). Plants should be placed on non-porous drip pans, well maintained and not overwatered. Picture 4 shows staining

Plant on towel

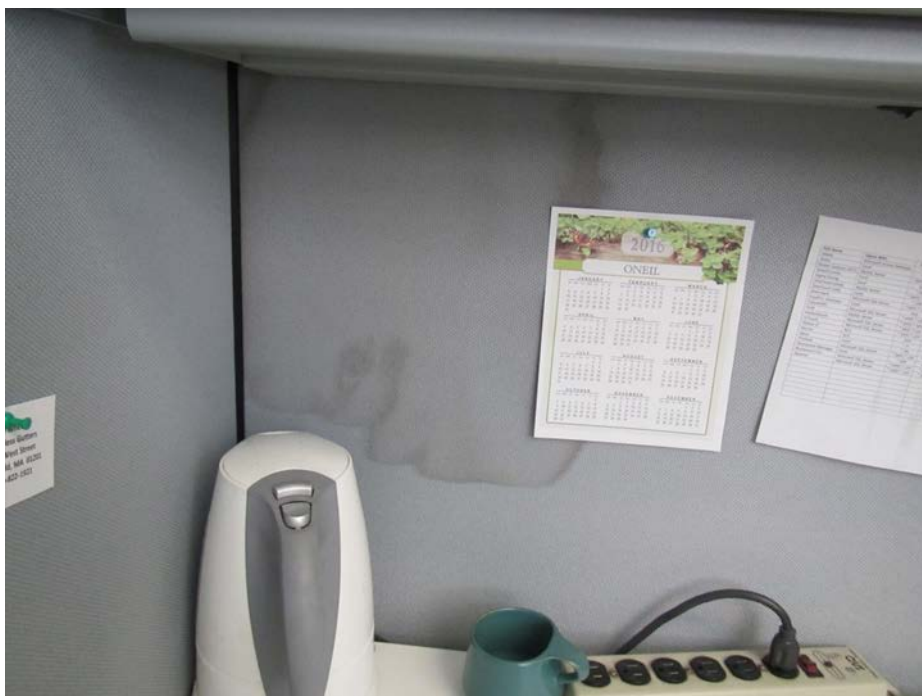
Picture 4

of the cloth workstation covering below the plant shown in Picture 3, indicating that excess water was used on this plant in the past.

Water stain on cloth divider from overwatering plant in Picture 3

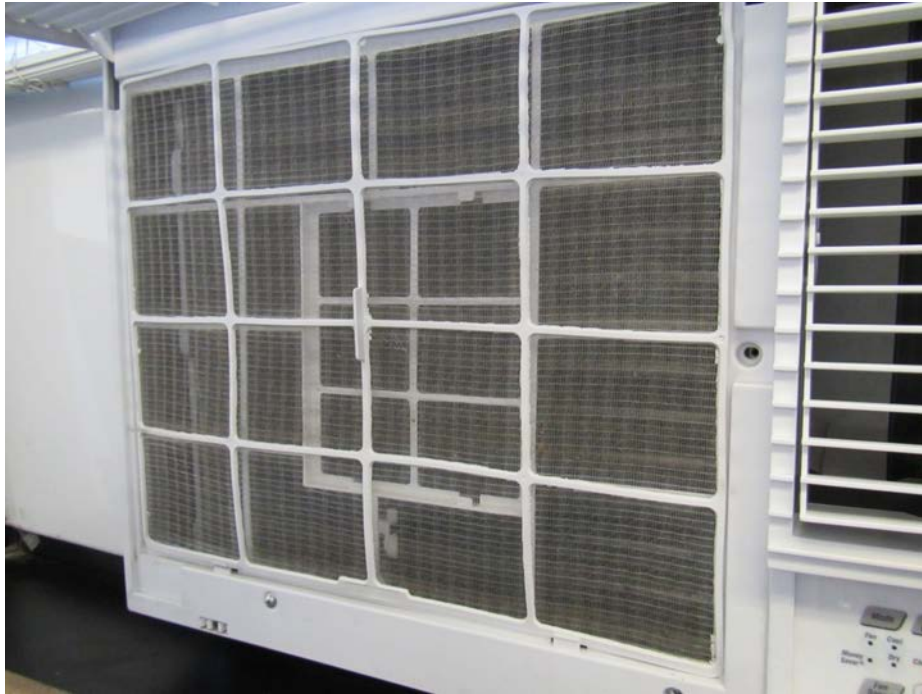
Picture 5

The window air conditioners are equipped with filters (Picture 5) which should be cleaned regularly to ensure proper function and prevent them becoming a source of particulates and odors to the indoor environment. In one location, a pencil sharpener was located next to a window air conditioner which can distribute particulates.

Window air conditioner filter (in good condition)

8. Clean the filters on WACs periodically.
9. Avoid placing pencil sharpeners and other sources of odors and particulates next to window air conditioners.
